CASE STUDY

BACTERIAL REMOVAL AND SCALE INHIBITION IN AN INDUSTRIAL COOLING TOWER USING CLEARITAS®

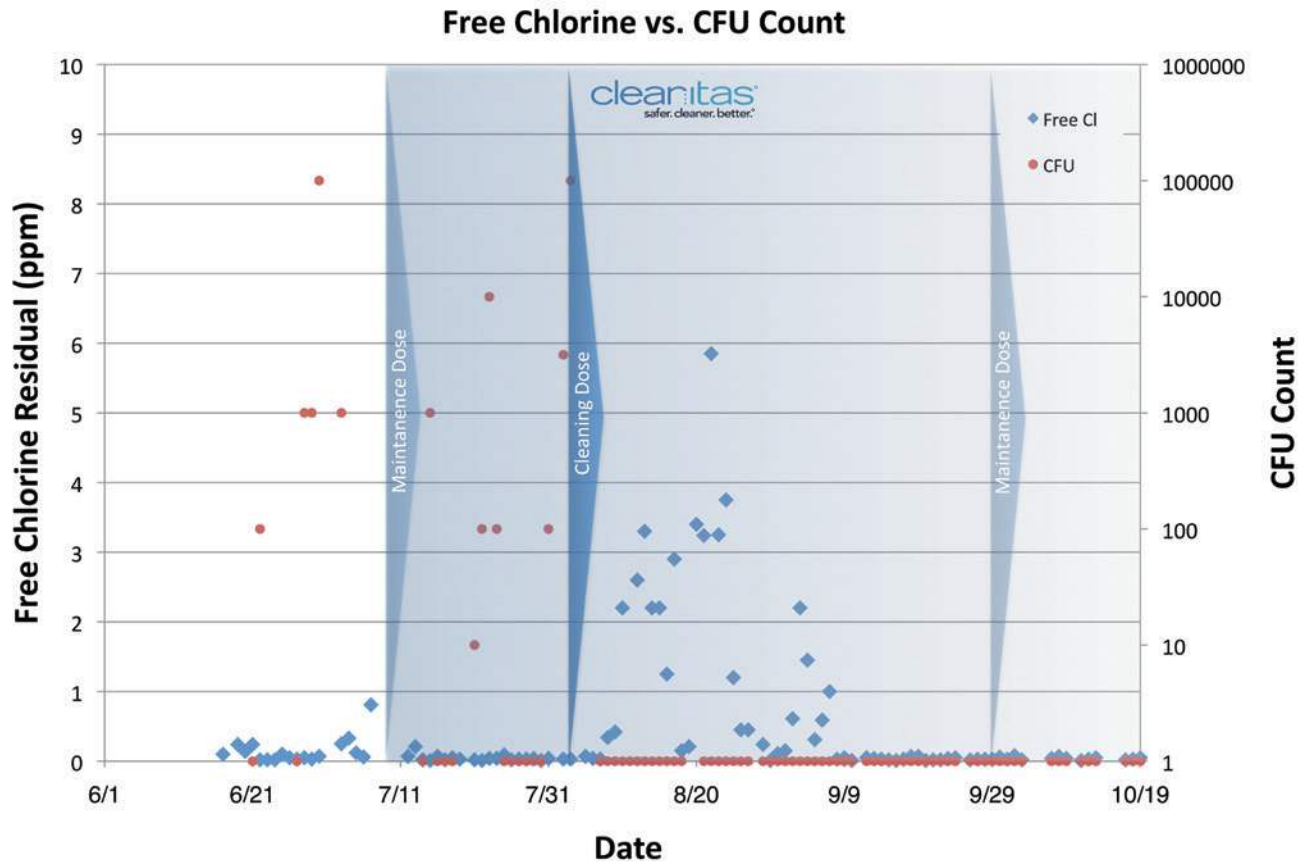
Figure 1 - Free chlorine residual vs. CFU count before, during, and after the Clearitas cleaning dose.

Figure 1 plots the CFUs measured within the cooling tower as well as the free chlorine residual. NOTE: The chlorine values are recorded daily and the CFU values are measured 2-3 times per week. As noted, the CFUs were not well controlled while on the prior chemical treatment. Additionally, very little free chlorine was in the system. Additional chemical analysis of both the source water and treated water confirmed that a large portion of the

During the initial Clearitas period, CFU counts did go down somewhat, but values did persist. Table 1 shows the average value of all the measurements taken. After the chemical changes to achieve free chlorine were made, the system quickly stabilized (starting around 8/8/2010). The free chlorine quickly rose and the CFU measurement went to zero and stayed at zero. Based on recommendations by Blue Earth Labs, the amount of HOCl added was brought back and maintained at a maintenance residual of 0.2–0.5 ppm.
