Water Quality

Reducing Chlorine Demand with Chemical Cleaning

by William W. Harjo, Charles Selvidge, and Ulrich Reimann-Philipp

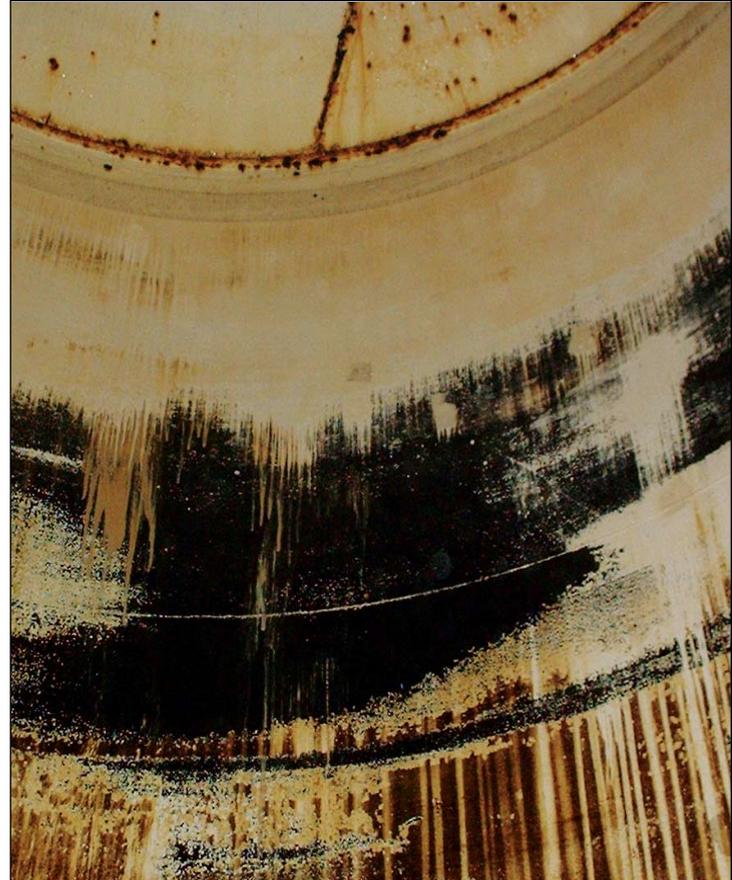
The cleaning solution produces an acidic reaction that works on all surfaces.

Chemical cleaning of the package treatment plant, the clearwell, and the first 1.2 mi of pipeline that served the town was completed within one day; during this time, the town's water supply came from the elevated tank. The first cleaning step was to drain and clean the plant. The cleaning solution was prepared by mixing the cleaner and activator components. The chemicals used are NSF-60 certified; the cleaner and activator combined produce an acidic reaction that works on all surfaces. The mixture is applied as a low-pressure mist using either an electrical pump and extendable spraying wand or hand-held sprayers.

Heavy surface deposits, built up over 15 years, covered the treatment unit. Some brushing was needed to support the chemical cleaning reaction. The treatment exposed the unit's epoxy coating and revealed paint that was generally in good condition, except for some small spots where the primer was exposed. After cleaning, the biodegradable solution was flushed out of the facility (the solution can also be recycled to the head of the treatment process at 1:500 dilution).

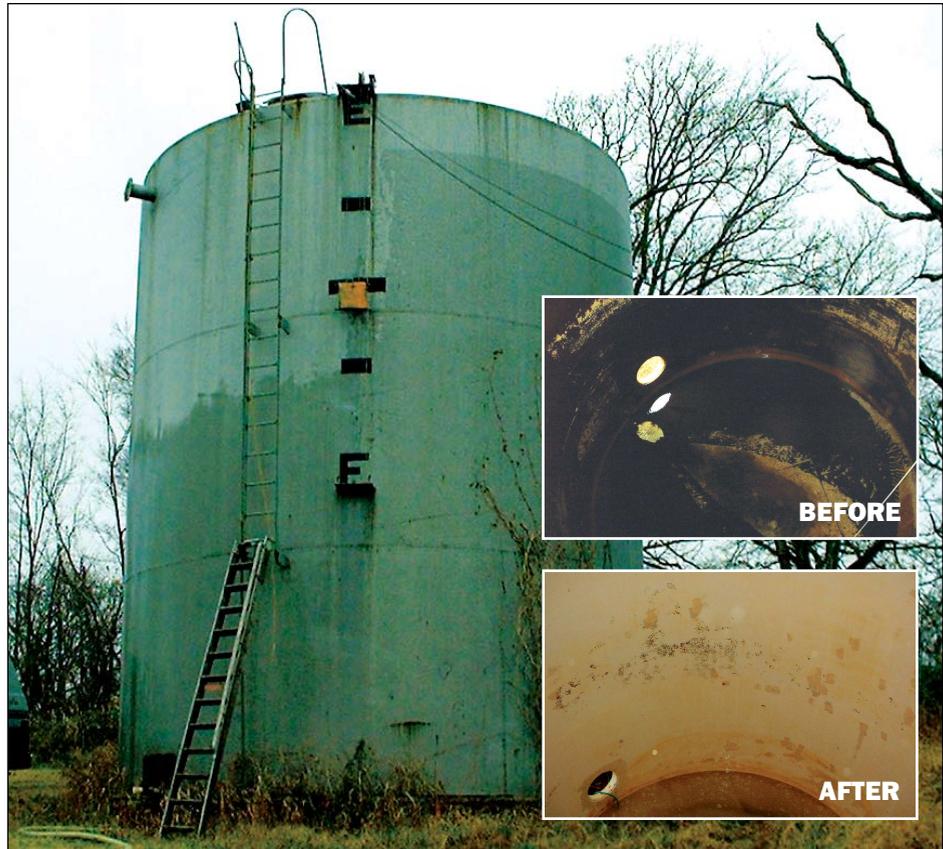
The clearwell's basin walls were covered with a black layer that was completely resistant to flushing with a fire hose (inset top). Chemical cleaning removed these deposits, without pressure washing or brushing (inset bottom).

The clearwell contained minimal sediment — mainly filter sand. However, a black layer that was completely resistant to firehose flushing covered the basin walls. Chemical cleaning, without pressure washing or brushing, removed these deposits. After cleaning the clearwell, the treatment unit was started so it would produce enough water to fill the section of pipeline to be treated. In the clearwell, the line treatment solution containing 0.5 percent of the activator component was prepared and pumped into the isolated line section, where it was allowed to react for 3 hr. During this time, the plant produced enough water
